Case Studies

RibLoc® RIB FRACTURE PLATING SYSTEM

Flail Chest | Acute Pain | Chest Wall Deformity | Fracture Non-union

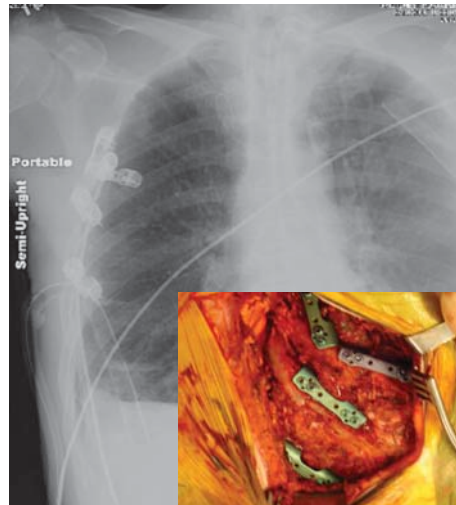
Post-Op

The patient initially underwent a right tube thoracostomy with a thoracic epidural for pain management. On day 4, the patient was unable to wean off the ventilator despite good ABG's. After 7 days the patient was still unable to wean off the ventilator, TV, and unable to wean pressure support. The patient's flail chest was surgically stabilized using the RibLoc Rib Fracture Plating System.

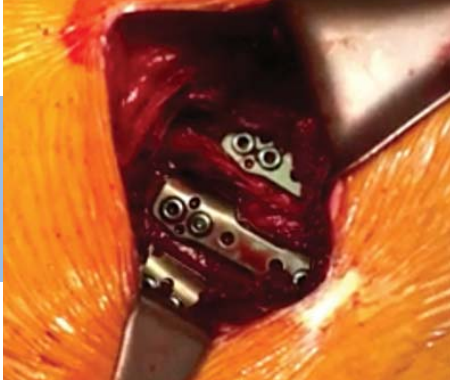
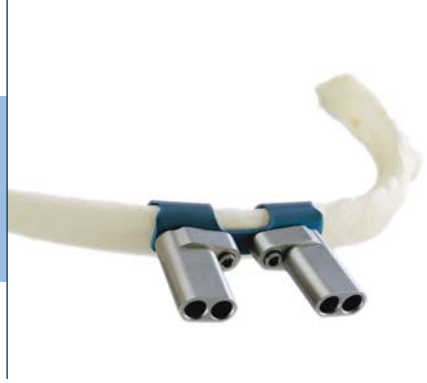
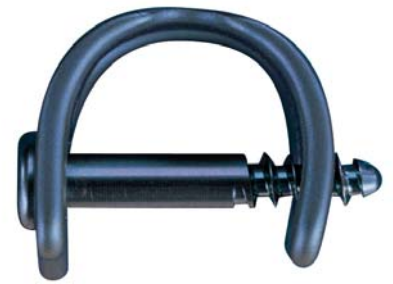
The plates in the system range from 46mm to 76mm in length. The 46mm plate requires only four screws for fixation. A 7-10cm incision allows multiple levels of fractures to be reached. 61mm & 76mm plates requiring slightly larger incisions, can address oblique or complicated fracture patterns. The system provides for preservation of the neurovascular bundle.

The plates are available in four sizes to match the anterior/posterior thickness of the rib. Color coding of the plates, screws and instrumentation ensures that the correct length of screw is used for the rib. The innovative targeting guides aid the surgeon installing the plates in a straightforward, precise and repeatable manner. All of these features were carefully developed to save OR time.

The plate's innovative U-shape and locking screws allows fixation to be independent of bone quality and/or screw purchase in the bone. The plate supports the fracture on three surfaces and avoids the neurovascular bundle on the inferior margin. This shorter U-shape construct has been shown to be biomechanically more stable compared to a longer anterior plate¹.
